# Hong Kong Airport Crash Incident 1999

## *Occurrence of the Aircraft Accident*

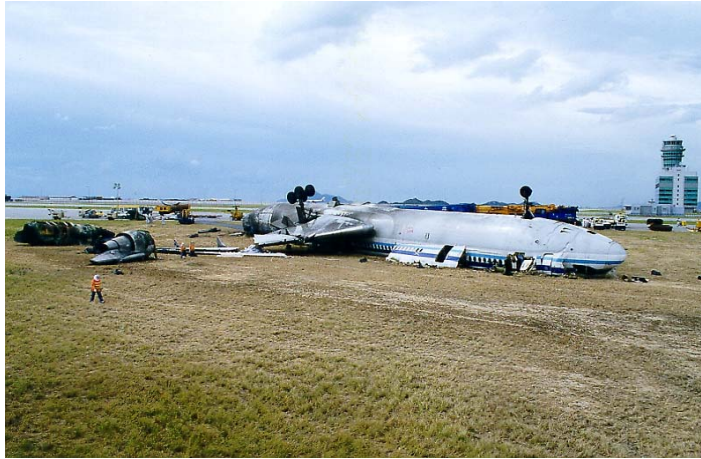
**Above : The wreckage of the inverted China Airlines MD-11 aircraft**

Upon arrival at the scene of crash, firemen found the aircraft fully overturned and lying on the grass area between taxiways J6 and J7. Its starboard wing was detached from the fuselage. The fuselage was engulfed in flames particularly in the region of the starboard wing, tail end and port wing. The No. 2 engine (from the tail) was also found detached and burning on the ground to the right of the aircraft's tail. In front of the nose of the aircraft, a long trail of about 100 x 20m of spilt fuel was burning vigorously. Large patches of spilt aviation fuel from the burst aircraft fuel tanks posed an imminent danger of triggering off a major ignition. The possibility of an explosion due to the engine and fuel lines was imminent. The explosive risk was endangering the lives of the 315 persons on board as well as the fire-fighting and rescue crews.

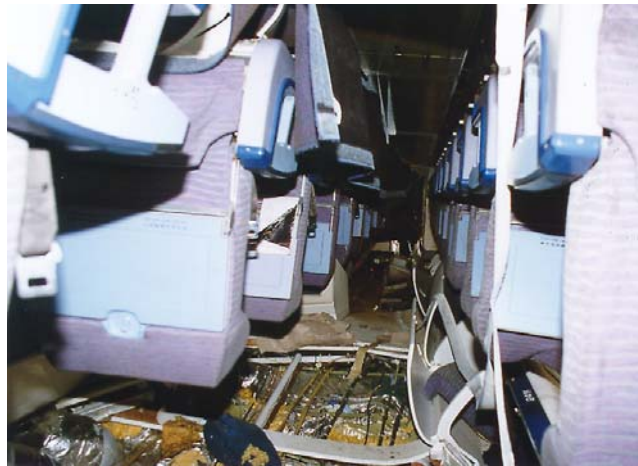
**Above : Absence of gangway inside the overturned fuselage**

Search and rescue inside the cabin was extremely onerous due to the narrow space, the large amount of scattered personal belongings, and the knee-deep water. Firemen literally combed under the water for possible casualties who might be submerged.

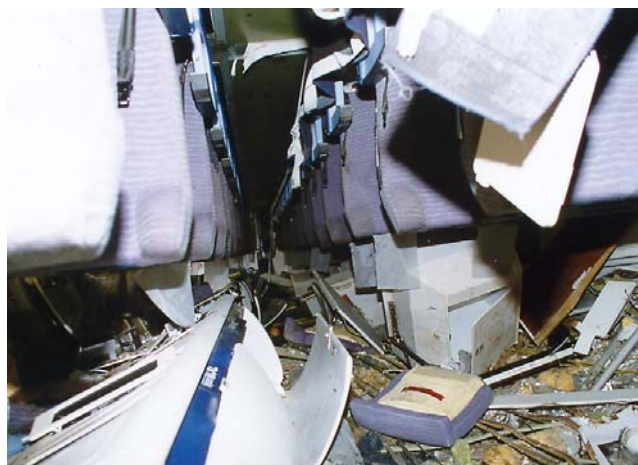
**Above : Scattered personal belongings and luggage restricted free movement**
